GUAM SHORE WAVE RECORDER INSTALLATION: II

M. A. Hall and R. L. Wiegel

DATE .... July, 1953 .....

Institute of Engineering Research  
Waves Research Laboratory  
Technical Report  
Series 3, Issue 354

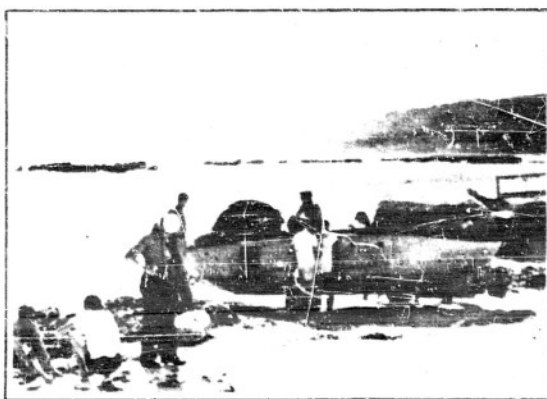
Fig. 9 - Airforce boat

Arrangements were made with the Commanding General, Anderson Air Force Base, Guam, M.I. for the use of a B29 air-sea rescue boat. This boat was 34 feet long, equipped with a 4 cylinder inboard engine, and had removable wheels, which made it possible to tow it by truck to the site in a short time (Figure 9). All arrangements could be made within eight hours for use of the boat, compared with the two weeks notice necessary with the ATF. Thus, if waves were forecast to be low for a twelve hour period, the boat could be towed by truck to the site, launched, and driven through the Tarague Channel to the instrument with enough time for the divers to work.
